Using Avance® Solo

A few things to keep in mind if you are receiving treatment with the Avance Solo Negative Pressure Wound Therapy (NPWT) system.

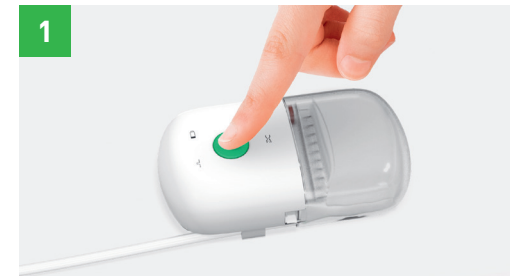
1 Pause the pump by pressing and holding the green start button and release after two (2) seconds. The pump will emit two beeps to confirm it is in a pause mode

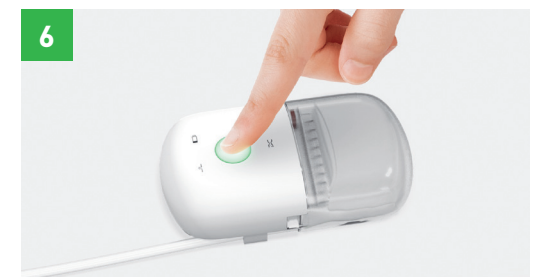
6 Restart therapy by pressing and holding the green button for two (2) seconds.

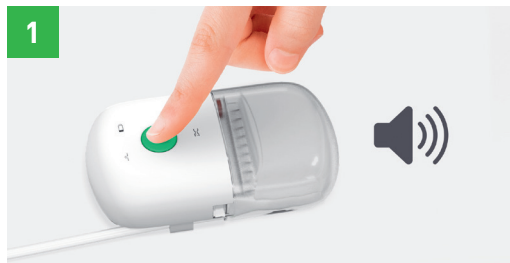
1 Pause the pump by pressing and holding the green start button and release after two (2) seconds. The pump will emit two beeps to confirm it is in a pause mode.

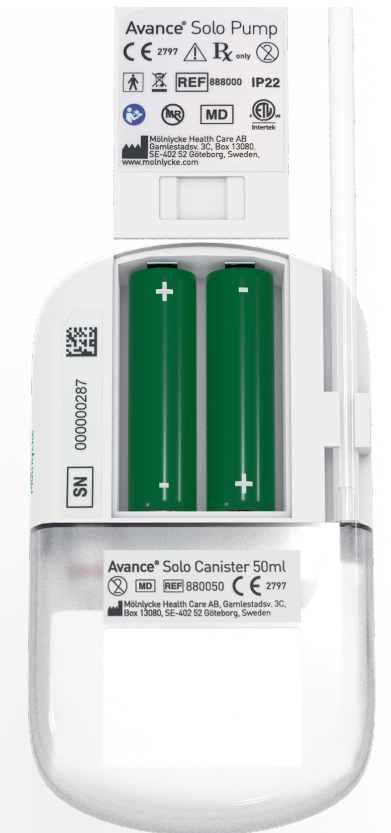
- If the pump is still active, pause the pump by pressing and holding the green start button and release after two (2) seconds.
- Open the battery compartment by sliding the lid.
- Remove the batteries and discard appropriately.
- Insert new batteries, ensuring that the positive terminal (marked +) and negative terminal (marked -) of each battery matches the +/- label in the battery compartment.
- Close the battery compartment lid.
- Restart the pump by pressing and holding down the green start button, release after two (2) seconds. Check that the negative pressure is active, the dressing should be contracted and firm to the touch.

You must change the two (2) batteries if there is a low battery alarm or after seven days. Only use AA 1.5V GP15LF lithium batteries. You have been provided with 4 x batteries for a total of up to 14 days' wear time if required.

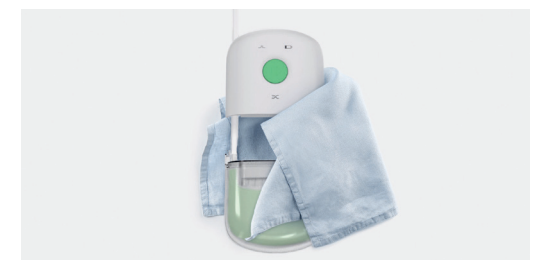
Occasional cleaning of the pump can be performed by wiping with a damp cloth or with a non-abrasive detergent. Do not put the pump under running water.
